**John Smith**

**123 Main Street  
USA**

May 06, 2020

## General Summary

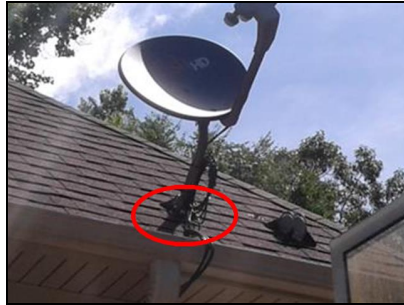
Sat dish attachment

Observed an active leak at the right rear roof area which is being caused by improper sealing where the satellite dish attaches to the roof. Condition is conducive to further damages. Evaluation / Correction by a qualified roofing contractor is recommended for this entire condition.

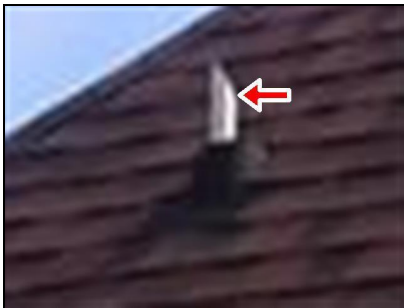
Plumbing vent pipe

Observed that the plumbing vent pipe on the right side is damaged at the top. Similar damage was also seen at other vent pipes along with the exhaust piping for the tankless water heater. All of this appears to be caused by rodent damages.

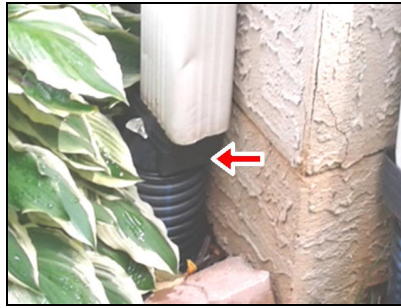
Disconnected downspout

Downspouts terminating at foundation wall. Missing diverter / splash block / leader pipes in various locations. Condition is conducive to crawl space water penetrations. Providing an adequate roof drainage system, diverting all downspouts away from the foundation and providing adequate soil grading and ground cover at the foundation and throughout the site are primary remedial factors to consider for any water penetration concerns. Downspouts that run into the ground are subject to backup / blockage. Neither the presence nor integrity of underground lines, nor free flow of water through such lines is determinable as part of this inspection.

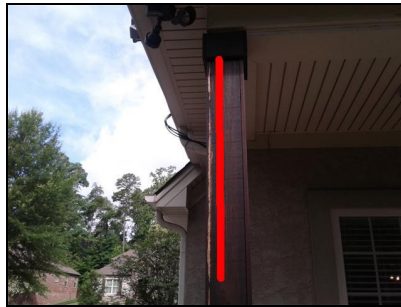
Right rear

Observed wood damage and deterioration at one of the rear porch columns. Condition is conducive to further damages. Evaluation / Correction by a qualified handyman contractor is recommended for this entire condition.

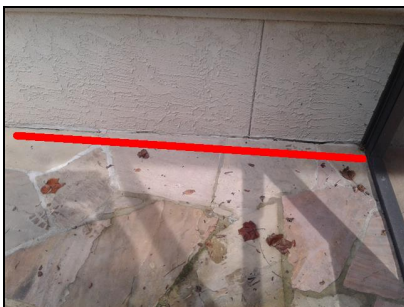
Rear stone patio

Observed openings in the grout / caulking that need to be resealed where the rear stone patio meets the exterior foundation wall. Condition is conducive to potential water penetrations. Evaluation / Correction by a qualified handyman contractor is recommended for this entire condition.

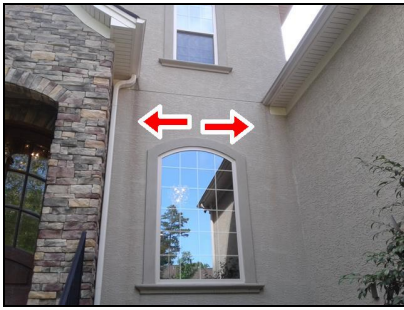
Front exterior wall

Observed water stains on the front exterior wall on both sides of the main dining room window. Due to the design of the roof valleys in relation to the upper second floor exterior walls this is common for this type of condition. Moisture readings were taken in multiple locations from the inside of the dining room which revealed water penetration damages. In addition a small amount of water from this condition was found in the crawlspace. This entire wall area needs to be exposed to further evaluate and determine the extent of

the damages. Further Investigation / Evaluation / Correction by a qualified general contractor is recommended for this entire condition.

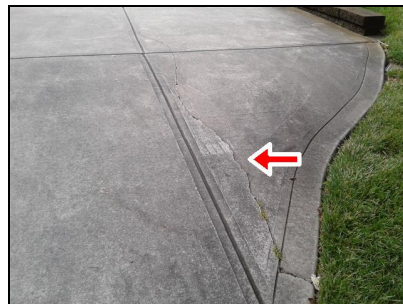
Typical cracking in driveway

Observed typical cracking in driveway due to age and typical masonry shrinkage. No displacement was observed at the time of inspection. Recommend sealing of cracks as needed / desired and then subsequent observation. Evaluation / Correction by a qualified handyman contractor is recommended for this entire condition.

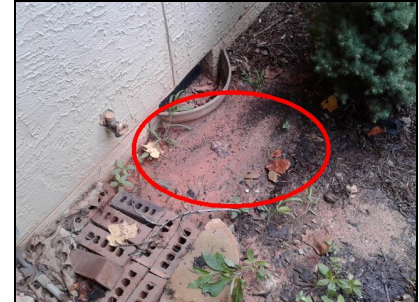
Rear off screen porch

Observed negative / flat grade slope toward the left side foundation wall and also at the rear foundation wall just off of screened porch area. These conditions allows for water runoff and ponding which could lead to water penetrations into the crawl space and other concerns. Although no water was observed in the crawl space at the time of inspection. Deficiencies should be corrected and suitable drainage conditions maintained in order to prevent any future problems. Evaluation / Correction by a qualified grading contractor is recommended for this entire condition.

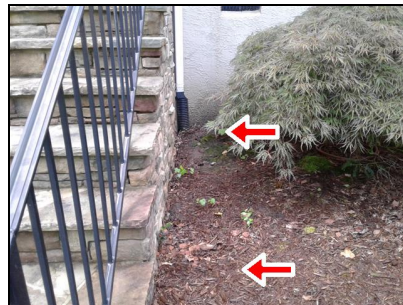
Front plant bed

Observed negative / flat grade slope toward the front of the foundation at the entry stairs. This allows water runoff and ponding which could lead to water penetrations and other concerns. Although no water was observed in the basement at the time of inspection. Deficiencies should be corrected and suitable drainage conditions maintained in order to prevent any future problems. Evaluation / Correction by a qualified contractor is recommended for this entire condition.

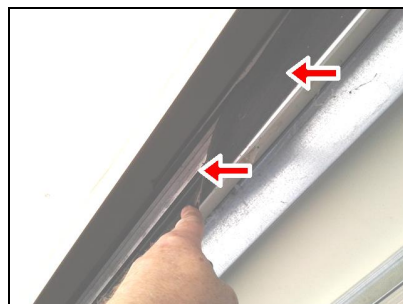
Large garage door

Observed that the garage door bottom weather stripping is damaged / missing / short and needs to be replaced. Condition is conducive to rodent and or water penetrations under the door. Evaluation / Correction by a qualified handyman contractor is recommended for this entire condition.

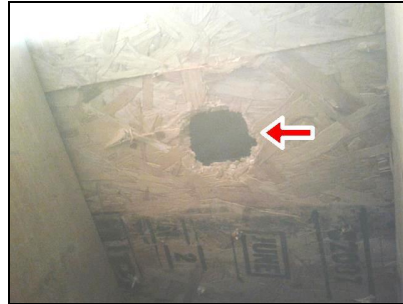
Left rear attic area

Observed a hole in the roof sheathing inside the left rear attic area. This hole needs to be plugged / patched to prevent any further damages. Evaluation / Correction by a qualified handyman contractor is recommended for this entire condition.

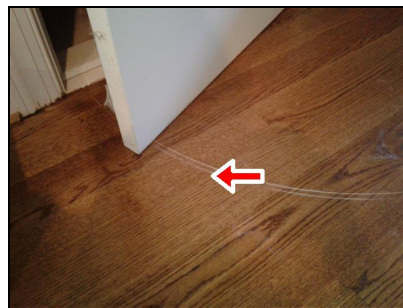
Bonus room storage door

Observed several interior doors that drag the floor. This can cause further damage to finished flooring materials. Evaluation / Correction by a qualified handyman contractor is recommended for this entire condition.

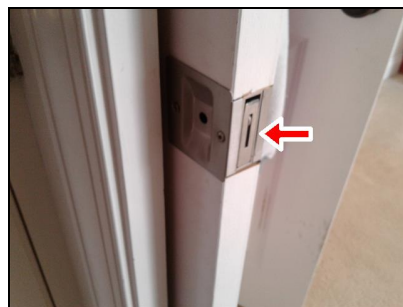
Rear hall bath pocket door  
frame

Observed that the entire latch assembly came out of the rear hall bath pocket door. Evaluation / Correction by a qualified handyman contractor is recommended for this entire condition.

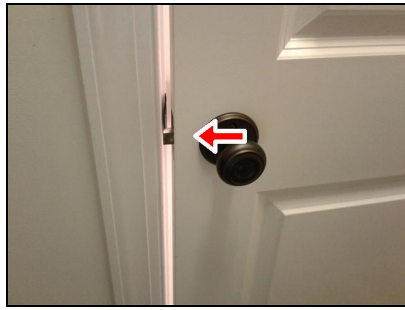
Middle bedroom closet door

Several of the room and closet doors have malfunctioning hardware that will not latch correctly. This is typically due to expansion and contraction from seasonal interior humidity. (Recommend checking all in all

locations) Evaluation / Correction by a qualified handyman contractor is recommended for this entire condition.

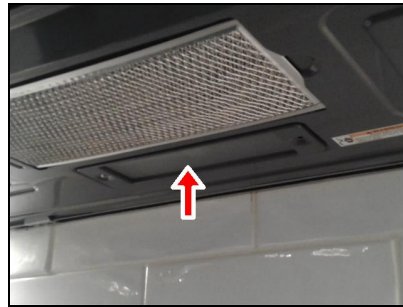
Microwave lights

Observed that the counter light bulbs are out on the microwave. Evaluation / Correction by a qualified handyman contractor is recommended for this entire condition.

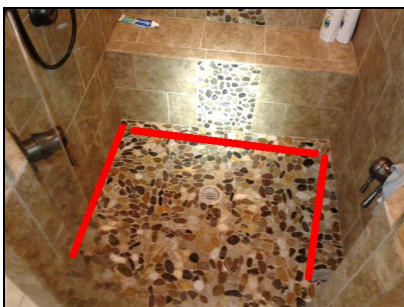
Master shower floor

Observed active leaking underneath the master bath tile shower floor. Tile based shower floors are prone to leaking and failure typically due to poor installation procedures and or lack of maintenance. Condition is conducive to other potential damages. Evaluation / Correction by a qualified general / tile contractor is recommended for this entire condition.

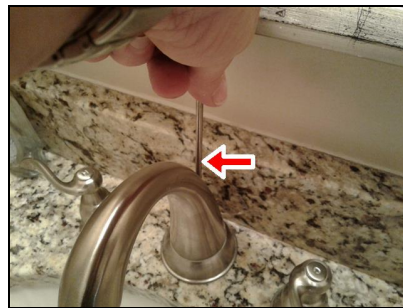
Front hall bath

Observed that the hall bath drain stopper did not function properly / missing / did not hold water. Evaluation / Correction by a qualified plumbing contractor is recommended for this entire condition.

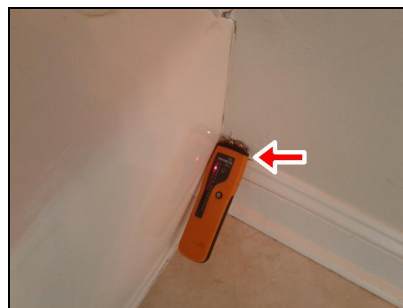
Right side hall bath tub

Observed high moisture content in the drywall outside of the tub at the second floor rear bathroom. This is typically due to the shower curtain not been close enough and water spilling out over the edge of the tub. Condition is conducive to further damages. Evaluation / Correction by a qualified handyman contractor is recommended for this entire condition.

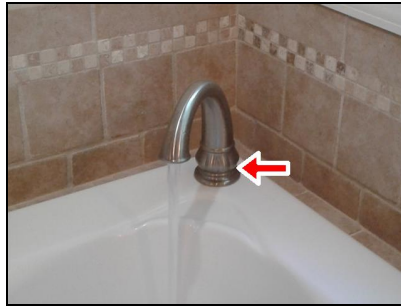
Master tub spout

Observed that the master bath tub spout is very loose where connects to the tub deck. Evaluation / Correction by a qualified handyman contractor is recommended for this entire condition.

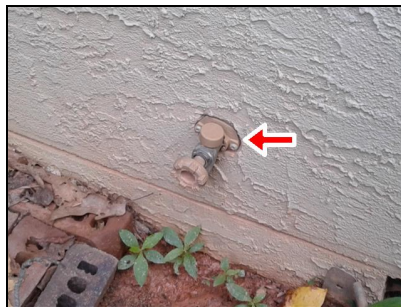
Rear off screen porch

Observed that the rear exterior water faucet that is located just off of the screened in porch was not able to be turned on due two rust and corrosion of the valve assembly. Condition is conducive to other damages. Evaluation / Correction by a qualified plumbing contractor is recommended for this entire condition.

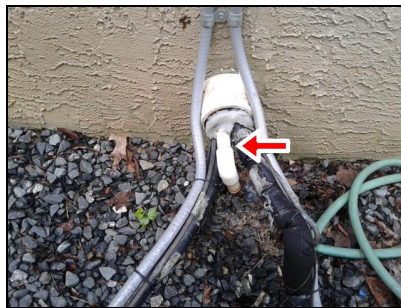
Condensation drain left side

Observed that the condensation drain lines need to be extended outward away from the foundation. Condition is conducive to water laying against foundation and crawl space water penetrations. This can also cause softening of the soils around the foundation and lead to other potential damages. Evaluation / Correction by a qualified handyman contractor is recommended for this entire condition.

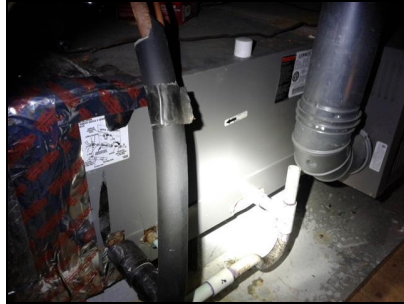
Second floor indoor AC coil unit

Per the standards of practice all NC / SC home inspectors are only required / allowed to remove readily accessible panels for inspection. In regards too the indoor coil units some of these panels cannot be removed due to design / obstructions / seal tape and or mastic compound. These indoor coil units work in tandem with the condenser unit outside to produce the air conditioning. Although temperature readings

indicate that the unit was functioning properly at the time of inspection, it is recommended that a qualified HVAC contractor further evaluate due to no service information revealed / given to FSHI at the time of inspection.

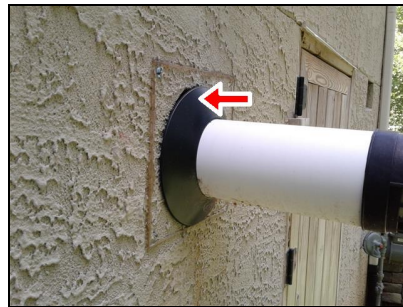
Tankless water heater vent

Observed that the exhaust pipe for the tankless water heater needs to be sealed around to prevent any water penetrations into the foundation wall. Condition is conducive to other damages. Evaluation / Correction by a qualified handyman contractor is recommended for this entire condition.

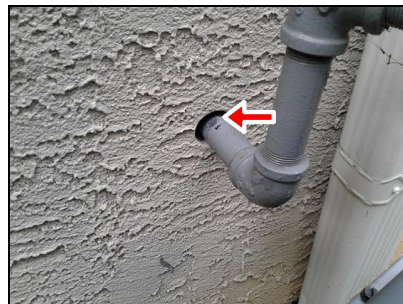
Gas line left side

Observed that caulk sealing needed at all pipes / wires where they pass through the foundation walls. Condition are conducive to water penetrations. Evaluation / Correction by a qualified handyman contractor is recommended for this entire condition.

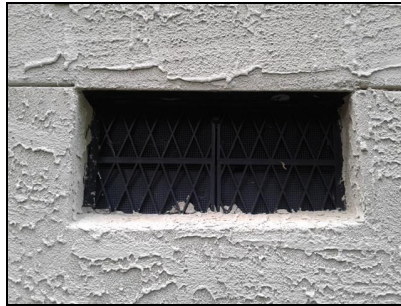
Closed vents

Some foundation vents were found closed. This condition restricts proper air flow and cross ventilation for crawlspace. Recommend keeping open all foundation vents open all year round to allow for proper cross ventilation. Foundation vents that are broken / missing need to be repaired / replaced. Vents that are below grade need to have vent wells installed.

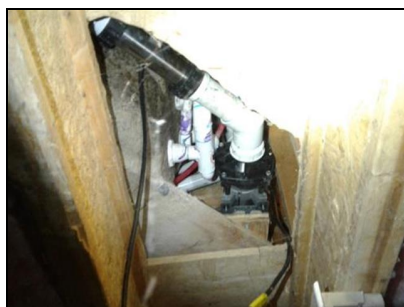
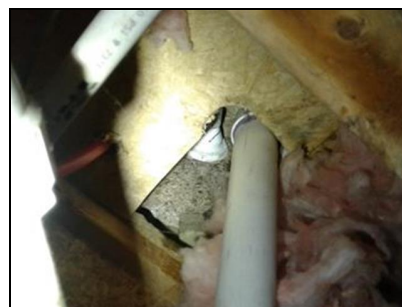
Under master tub

Observed access areas underneath the master bath tub that were open to the crawlspace. These areas need to be blocked off to prevent any potential rodent penetrations up into the living space of the home. In addition once these areas are blocked off the floor system underneath the bath tub needs to also be insulated. Evaluation / Correction by a qualified handyman contractor is recommended for this entire condition.

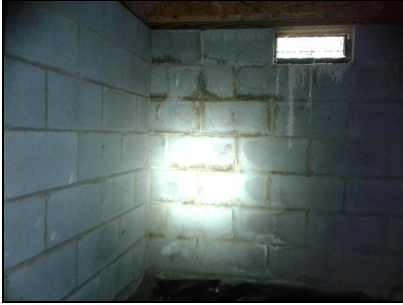
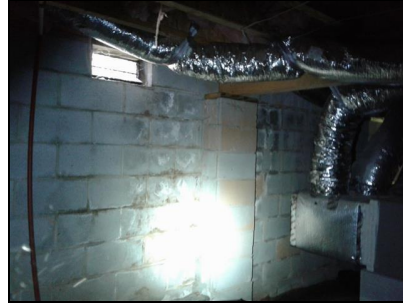
**Foundation wall under dining room**

Observed evidence of active water penetrations at the foundation wall under the dining room that is collecting and the left front corner. This water penetration is directly related to the conditions at the front dining room area of the home. (See Exterior). Providing an adequate roof drainage system, diverting all downspouts away from the foundation and providing adequate soil grading and ground cover at the foundation and throughout the site are primary remedial factors to consider for any water penetration concerns. Improper or negative grading / drainage and crawl space vents at or below grade can cause water penetrations. All deficiencies must be corrected to prevent problems. Evaluation / Correction by a qualified contractor is recommended for this entire condition.

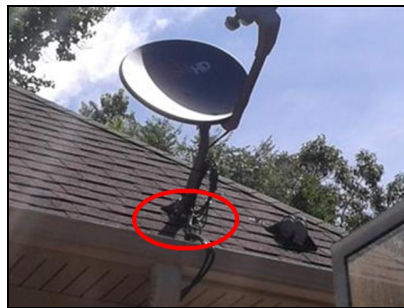
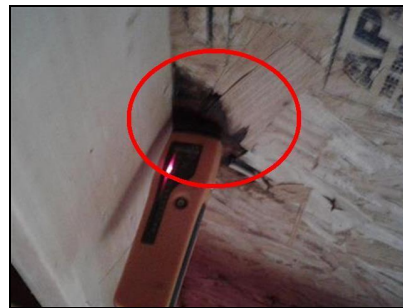
Sat dish attachment

**1.0** Observed an active leak at the right rear roof area which is being caused by improper sealing where the satellite dish attaches to the roof. Condition is conducive to further damages. Evaluation / Correction by a qualified roofing contractor is recommended for this entire condition.

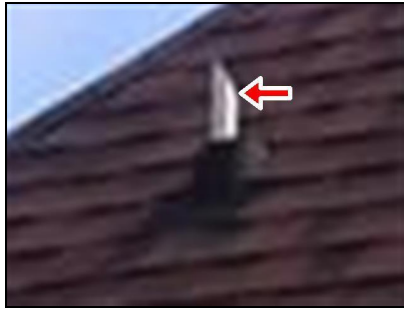
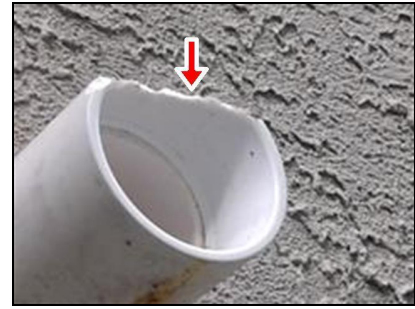
Plumbing vent pipe

**1.4** Observed that the plumbing vent pipe on the right side is damaged at the top. Similar damage was also seen at other vent pipes along with the exhaust piping for the tankless water heater. All of this appears to be caused by rodent damages.

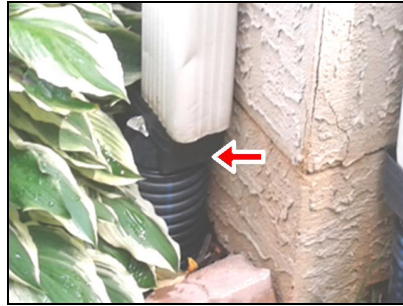
Disconnected downspout

**1.6** Downspouts terminating at foundation wall. Missing diverter / splash block / leader pipes in various locations. Condition is conducive to crawl space water penetrations. Providing an adequate roof drainage system, diverting all downspouts away from the foundation and providing adequate soil grading and ground cover at the foundation and throughout the site are primary remedial factors to consider for any water penetration concerns. Downspouts that run into the ground are subject to backup / blockage. Neither the presence nor integrity of underground lines, nor free flow of water through such lines is determinable as part of this inspection.

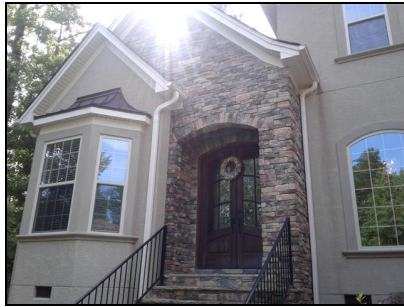
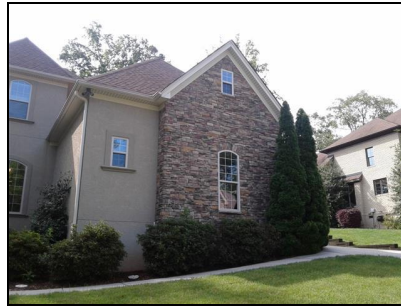
Stone veneer

**2.1** Observed some but not all portions of this home are clad with a manufactured stone product. There have been several documented concerns of this type of manufactured stone system in regards to installation procedures and potential water penetrations. Although no water damages or evidence of water penetrations were found (behind the stones areas of the home) the client is advised to seek further consultation from a qualified stone contractor in regards to further evaluation and continual maintenance.

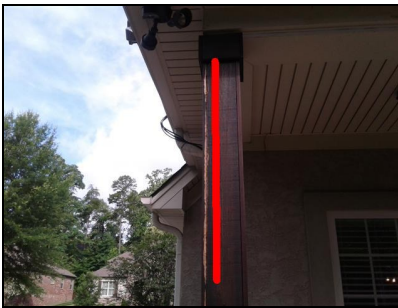
Right rear

**2.2** Observed wood damage and deterioration at one of the rear porch columns. Condition is conducive to further damages. Evaluation / Correction by a qualified handyman contractor is recommended for this entire condition.

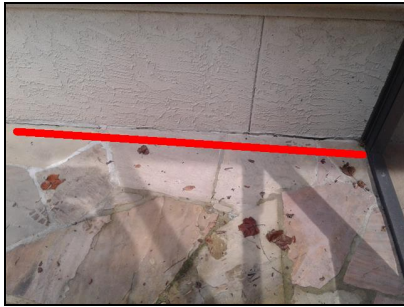
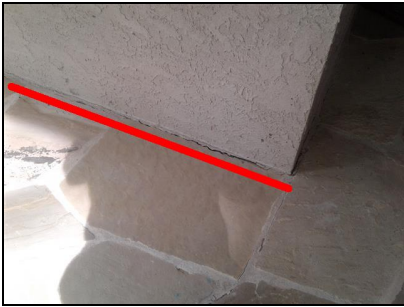
Rear stone patio

**2.5** Observed openings in the grout / caulking that need to be resealed where the rear stone patio meets the exterior foundation wall. Condition is conducive to potential water penetrations. Evaluation / Correction by a qualified handyman contractor is recommended for this entire condition.

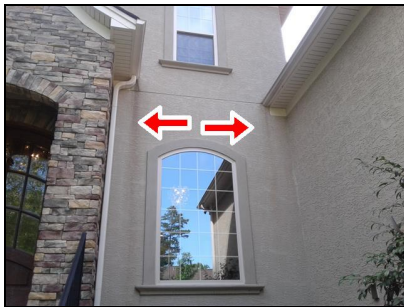
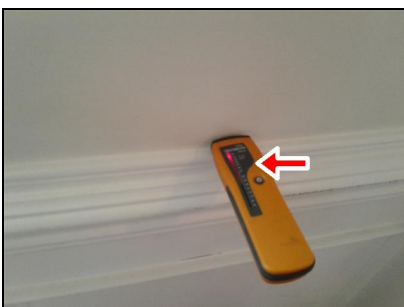
Front exterior wall

**2.9** Observed water stains on the front exterior wall on both sides of the main dining room window. Due to design of the roof valleys in relation to the upper second floor exterior walls this common for this type of condition. Moisture readings were taken in multiple locations from the inside of the dining room which revealed water penetration damages. In addition a small amount of water from this condition was found in the crawlspace. This entire wall area needs to be exposed too further evaluate and determine the extent of the damages. Further Investigation / Evaluation / Correction by a qualified general contractor is recommended for this entire condition.

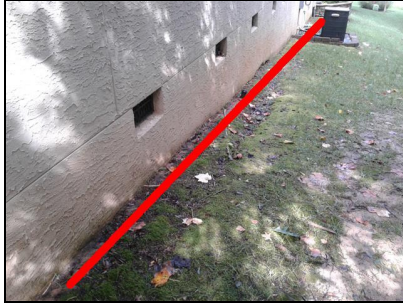
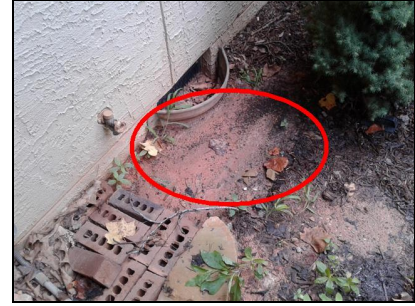
Left side

**3.3** Observed negative / flat grade slope toward the left side foundation wall and also at the rear foundation wall just off of screened porch area. These conditions allows for water runoff and ponding which could lead to water penetrations into the crawl space and other concerns. Although no water was observed in the crawl space at the time

of inspection. Deficiencies should be corrected and suitable drainage conditions maintained in order to prevent any future problems. Evaluation / Correction by a qualified grading contractor is recommended for this entire condition.

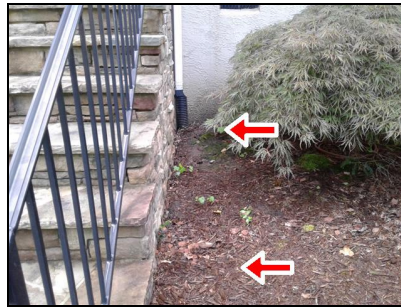
Front plant bed

**3.3** Observed negative / flat grade slope toward the front of the foundation at the entry stairs. This allows water runoff and ponding which could lead to water penetrations and other concerns. Although no water was observed in the basement at the time of inspection. Deficiencies should be corrected and suitable drainage conditions maintained in order to prevent any future problems. Evaluation / Correction by a qualified contractor is recommended for this entire condition.

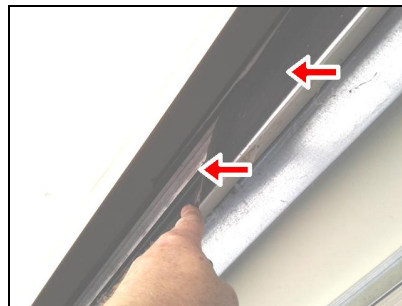
Large garage door

**4.2** Observed that the garage door bottom weather stripping is damaged / missing / short and needs to be replaced. Condition is conducive to rodent and or water penetrations under the door. Evaluation / Correction by a qualified handyman contractor is recommended for this entire condition.

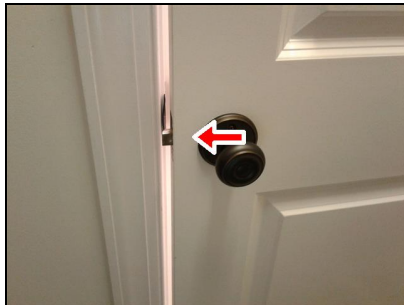
Middle bedroom closet door

**6.6** Several of the room and closet doors have malfunctioning hardware that will not latch correctly. This is typically due to expansion and contraction from seasonal interior humidity. (Recommend checking all in all locations)  
Evaluation / Correction by a qualified handyman contractor is recommended for this entire condition.

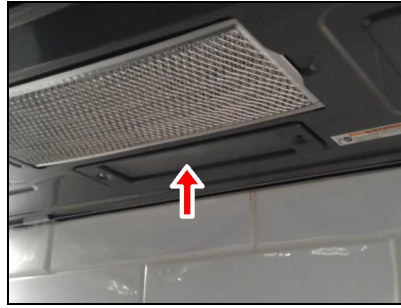
Microwave lights

**7.6** Observed that the counter light bulbs are out on the microwave. Evaluation / Correction by a qualified handyman contractor is recommended for this entire condition.

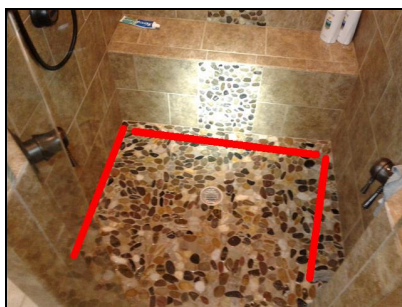
Master shower floor

**8.3.A** Observed active leaking underneath the master bath tile shower floor. Tile based shower floors are prone to leaking and failure typically due to poor installation procedures and or lack of maintenance. Condition is conducive to other potential damages. Evaluation / Correction by a qualified general / tile contractor is recommended for this entire condition.

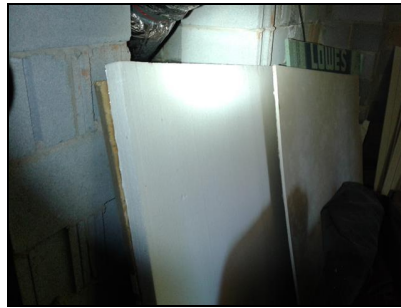
Wood The products in crawspace

Observed wood debris and other trash items in the crawl space. All wood, trash or cardboard debris must be kept out of crawl space areas. Condition is conducive to wood destroying insects and other potential concerns.

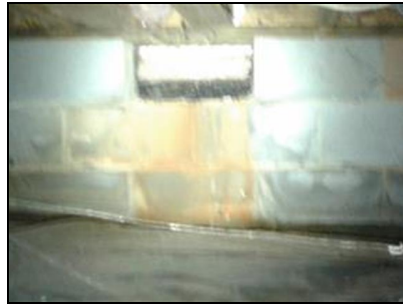
Rear foundation wall

Observed evidence of previous water penetrations along the left rear foundation wall area. Evidence shows that water has been coming through the crawlspace vent. No standing water was observed at the time of inspection but evidence shows that water had penetrated recently. Providing an adequate roof drainage system, diverting all downspouts away from the foundation and providing adequate soil grading and ground cover at the foundation and throughout the site are primary remedial factors to consider for any water penetration concerns. Improper or negative grading / drainage and crawl space vents at or below grade can cause water penetrations. All deficiencies must be corrected to prevent problems. Evaluation / Correction by a qualified contractor is recommended for this entire condition.
