**John Smith**

**123 Main Street  
USA**

May 06, 2020

## General Summary

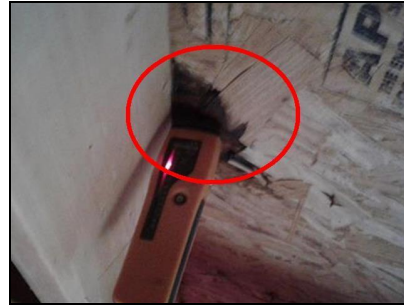
Right rear

Observed an active leak at the right rear roof area which is being caused by improper sealing where the satellite dish attaches to the roof. Condition is conducive to further damages. Evaluation / Correction by a qualified roofing contractor is recommended for this entire condition.

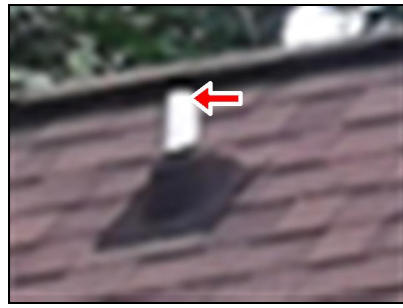
Plumbing vent pipe

Observed that the plumbing vent pipe on the right side is damaged at the top. Similar damage was also seen at other vent pipes along with the exhaust piping for the tankless water heater. All of this appears to be caused by rodent damages.

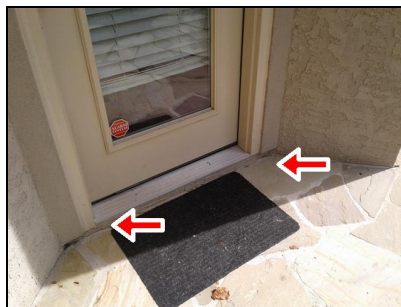
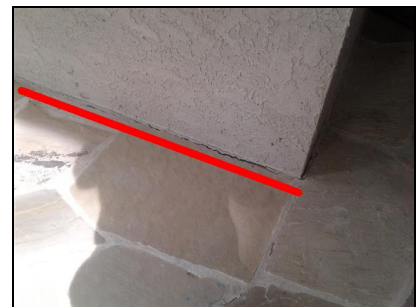
Rear stone patio

Observed openings in the grout / caulking that need to be resealed where the rear stone patio meets the exterior foundation wall. Condition is conducive to potential water penetrations. Evaluation / Correction by a qualified handyman contractor is recommended for this entire condition.

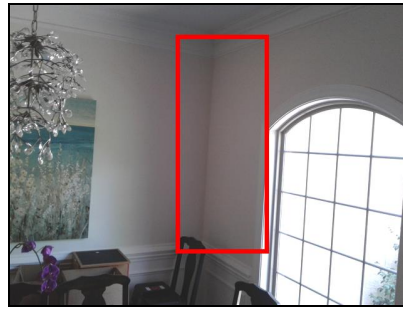
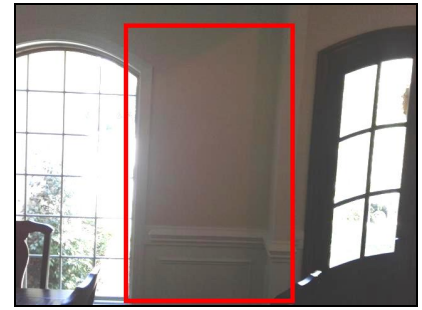
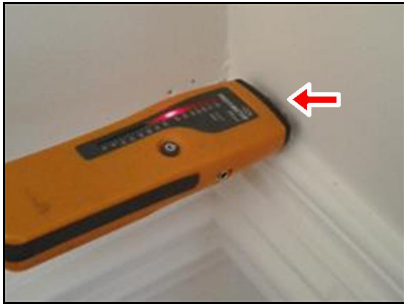
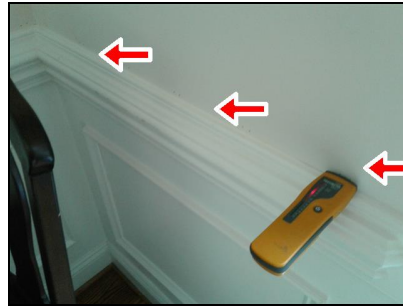
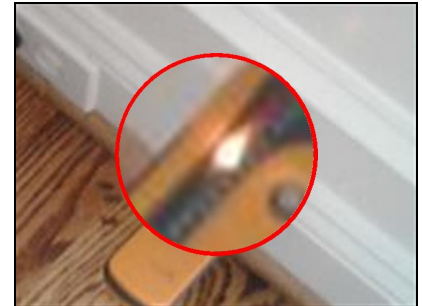
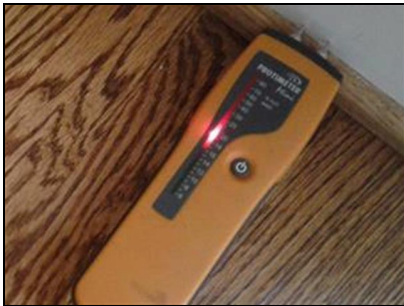
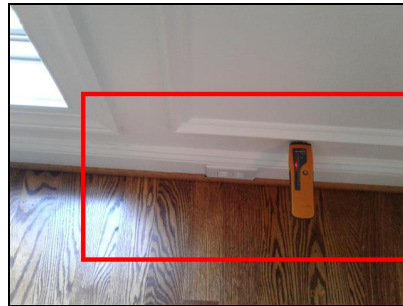
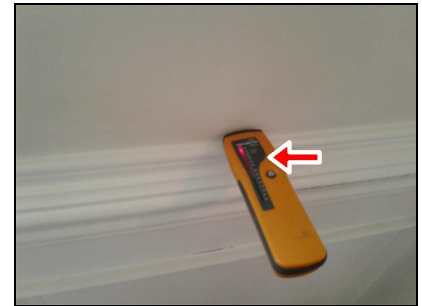
Observed water stains on the front exterior wall on both sides of the main dining room window. Due to the design of the roof valleys in relation to the upper second floor exterior walls this is common for this type of condition. Moisture readings were taken in multiple locations from the inside of the dining room which revealed water penetration damages. In addition a small amount of water from this condition was found in the crawlspace. This entire wall area needs to be exposed to further evaluate and determine the extent of

the damages. Further Investigation / Evaluation / Correction by a qualified general contractor is recommended for this entire condition.

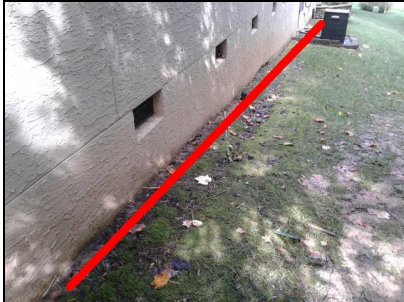
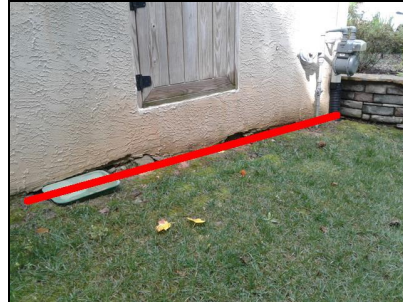
Left side

Observed negative / flat grade slope toward the left side foundation wall and also at the rear foundation wall just off of screened porch area. These conditions allows for water runoff and ponding which could lead to water penetrations into the crawl space and other concerns. Although no water was observed in the crawl space at the time of inspection. Deficiencies should be corrected and suitable drainage conditions maintained in order to prevent any future problems. Evaluation / Correction by a qualified grading contractor is recommended for this entire condition.

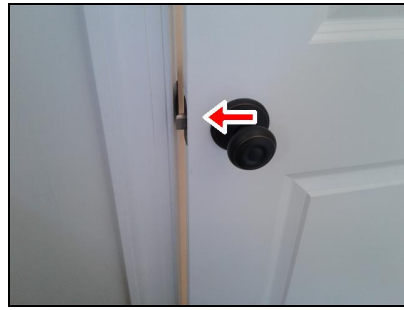
Laundry room door

Several of the room and closet doors have malfunctioning hardware that will not latch correctly. This is typically due to expansion and contraction from seasonal interior humidity. (Recommend checking all in all

locations) Evaluation / Correction by a qualified handyman contractor is recommended for this entire condition.

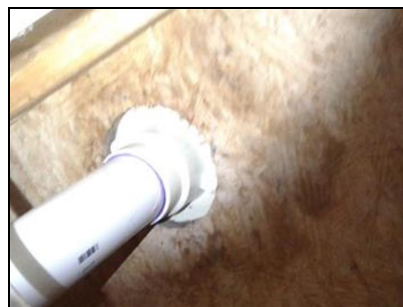
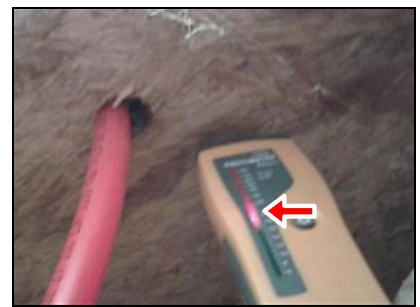
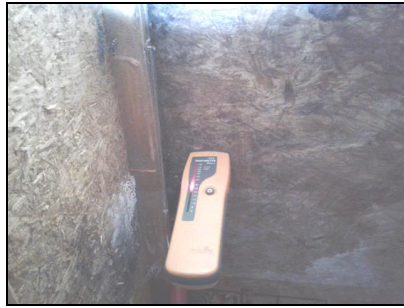
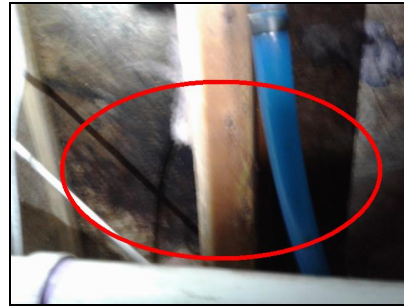
Under master shower

Observed active leaking underneath the master bath tile shower floor. Tile based shower floors are prone to leaking and failure typically due to poor installation procedures and or lack of maintenance. Condition is conducive to other potential damages. Evaluation / Correction by a qualified general / tile contractor is recommended for this entire condition.

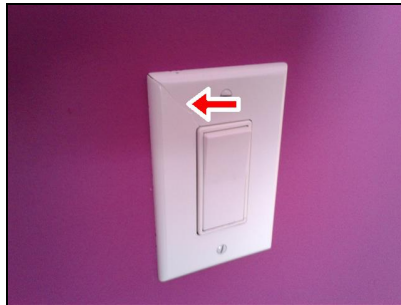
RR bedroom closet

Observed a broken switch cover at the right rear bedroom closet. Evaluation / Correction by a qualified handyman contractor is recommended for this entire condition.

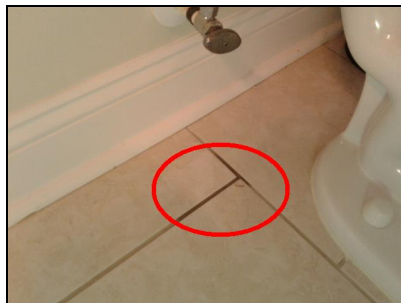
Rear bath under toilet

Observed a small amount of moisture content at the tile floor right underneath the master bathroom toilet water supply valve. Although the tile floor was wet there was no active leaking was found at the time of inspection. Evaluation / Correction by a qualified handyman contractor is recommended for this entire condition.

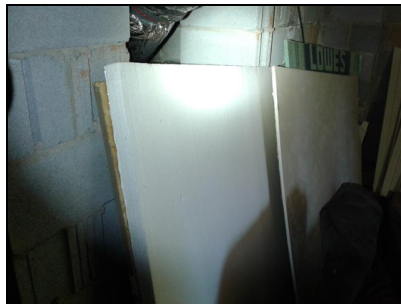
Wood The products in crawlspace

Observed wood debris and other trash items in the crawl space. All wood, trash or cardboard debris must be kept out of crawl space areas. Condition is conducive to wood destroying insects and other potential concerns.

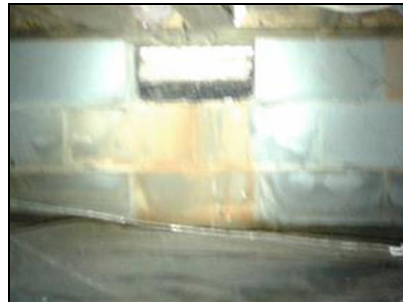
**Rear foundation wall**

Observed evidence of previous water penetrations along the left rear foundation wall area. Evidence shows that water has been coming through the crawlspace vent. No standing water was observed at the time of inspection but evidence shows that water had penetrated recently. Providing an adequate roof drainage system, diverting all downspouts away from the foundation and providing adequate soil grading and ground cover at the foundation and throughout the site are primary remedial factors to consider for any water penetration concerns. Improper or negative grading / drainage and crawl space vents at or below grade can cause water penetrations. All deficiencies must be corrected to prevent problems. Evaluation / Correction by a qualified contractor is recommended for this entire condition.

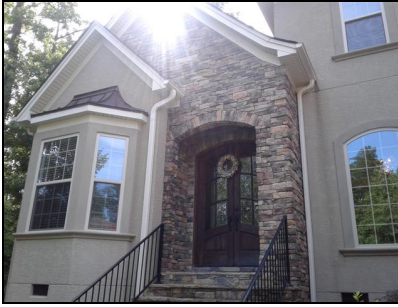
Hard coat stucco

**2.0** Observed that the exterior of this home is clad with a hard coat stucco. Although the hard coat stucco system It is generally a better product, there have been some documented concerns in regards to the potential for water penetrations. The client is advised to seek further consultation from a qualified stucco contractor in regards to continual maintenance.

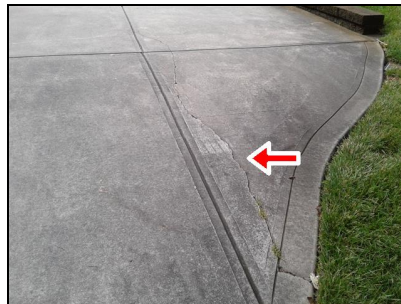
Typical cracking in driveway

**3.2** Observed typical cracking in driveway due to age and typical masonry shrinkage. No displacement was observed at the time of inspection. Recommend sealing of cracks as needed / desired and then subsequent observation. Evaluation / Correction by a qualified handyman contractor is recommended for this entire condition.

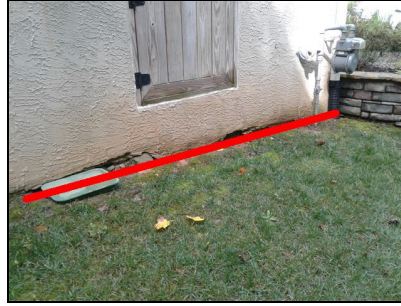
Left side

**3.3** Observed negative / flat grade slope toward the left side foundation wall and also at the rear foundation wall just off of screened porch area. These conditions allows for water runoff and ponding which could lead to water penetrations into the crawl space and other concerns. Although no water was observed in the crawl space at the time

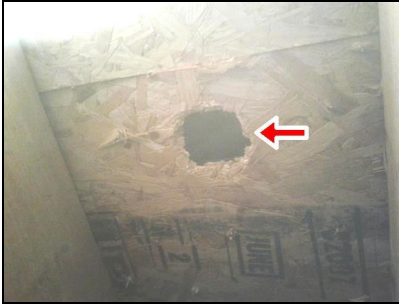
Left rear attic area

**5.1** Observed a hole in the roof sheathing inside the left rear attic area. This hole needs to be plugged / patched to prevent any further damages. Evaluation / Correction by a qualified handyman contractor is recommended for this entire condition.

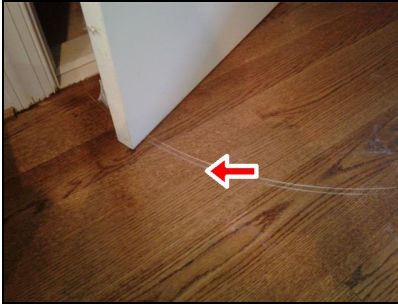
Bonus room storage door

**6.6** Observed several interior doors that drag the floor. This can cause further damage to finished flooring materials. Evaluation / Correction by a qualified handyman contractor is recommended for this entire condition.

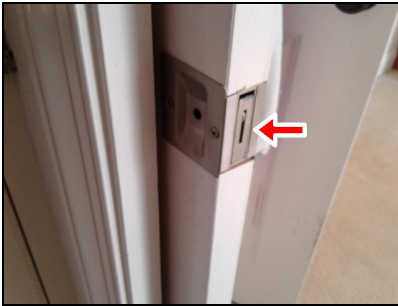
Rear hall bath pocket door frame

**6.6** Observed that the entire latch assembly came out of the rear hall bath pocket door. Evaluation / Correction by a qualified handyman contractor is recommended for this entire condition.

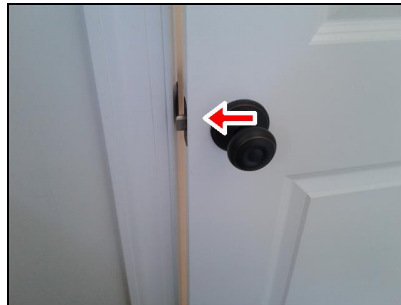
Laundry room door

**6.6** Several of the room and closet doors have malfunctioning hardware that will not latch correctly. This is typically due to expansion and contraction from seasonal interior humidity. (Recommend checking all in all locations)  
Evaluation / Correction by a qualified handyman contractor is recommended for this entire condition.

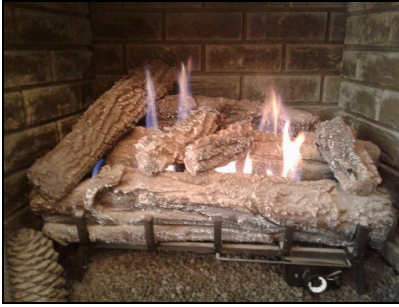
**6.10** Per the FSHI Report Guarantee Program this item is rated fair due to age but functions as intended.

Fireplace running at inspection

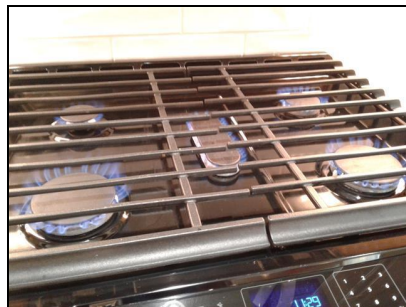
**7.3** Per the FSHI Report Guarantee Program this item is rated fair due to age but functions as intended.

Gas range on

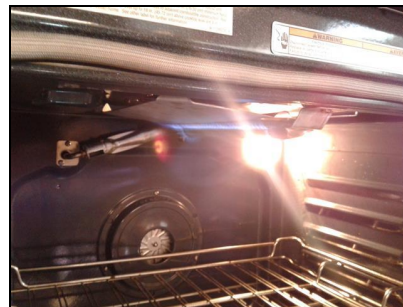
Broiler element on

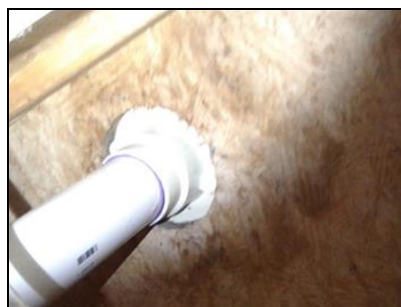
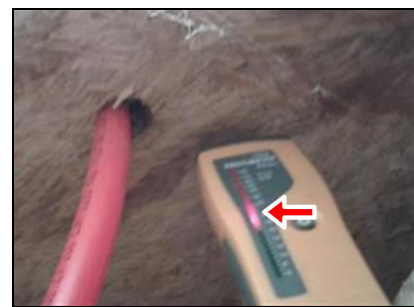
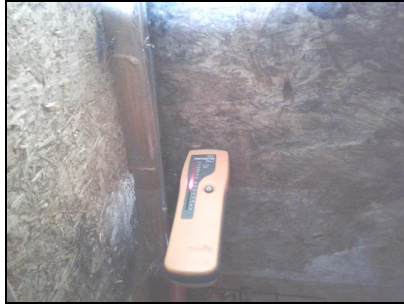
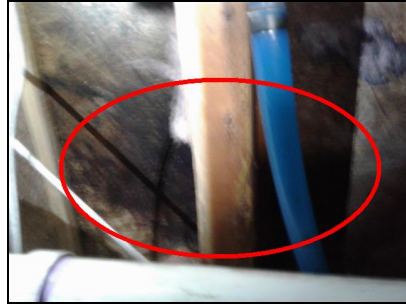
Under master shower

**8.3.A** Observed active leaking underneath the master bath tile shower floor. Tile based shower floors are prone to leaking and failure typically due to poor installation procedures and or lack of maintenance. Condition is conducive to other potential damages. Evaluation / Correction by a qualified general / tile contractor is recommended for this entire condition.

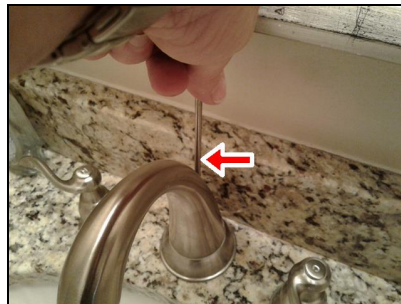
Front hall bath

**8.0.B** Observed that the hall bath drain stopper did not function properly / missing / did not hold water. Evaluation / Correction by a qualified plumbing contractor is recommended for this entire condition.

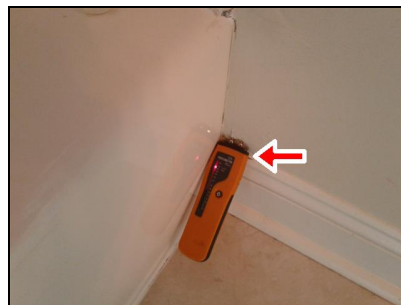
Right side hall bath tub

**8.4.C** Observed high moisture content in the drywall outside of the tub at the second floor rear bathroom. This is typically due to the shower curtain not been close enough and water spilling out over the edge of the tub. Condition is conducive to further damages. Evaluation / Correction by a qualified handyman contractor is recommended for this entire condition.

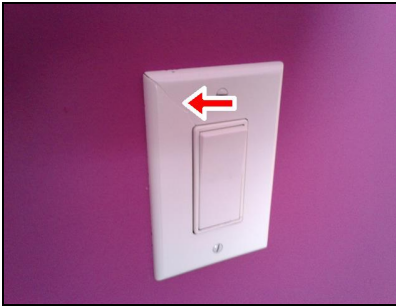
RR bedroom closet

**9.4** Observed a broken switch cover at the right rear bedroom closet. Evaluation / Correction by a qualified handyman contractor is recommended for this entire condition.

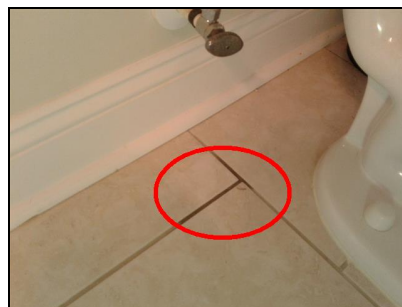
Rear bath under toilet

**10.1** Observed a small amount of moisture content at the tile floor right underneath the master bathroom toilet water supply valve. Although the tile floor was wet there was no active leaking was found at the time of inspection. Evaluation / Correction by a qualified handyman contractor is recommended for this entire condition.

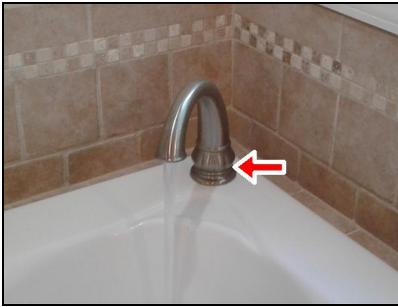
Master tub spout

**10.1** Observed that the master bath tub spout is very loose where connects to the tub deck. Evaluation / Correction by a qualified handyman contractor is recommended for this entire condition.

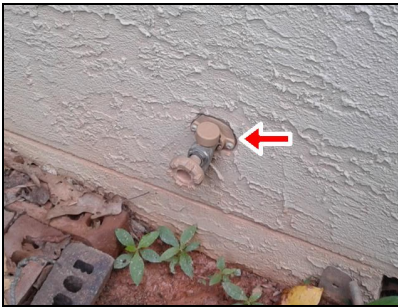
Rear off screen porch

**10.5** Observed that the rear exterior water faucet that is located just off of the screened in porch was not able to be turned on due two rust and corrosion of the valve assembly. Condition is conducive to other damages. Evaluation / Correction by a qualified plumbing contractor is recommended for this entire condition.

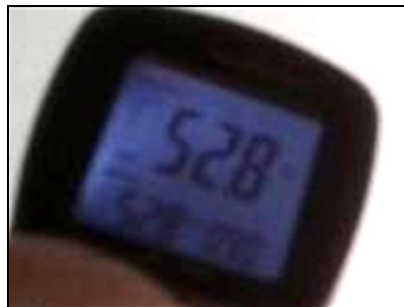
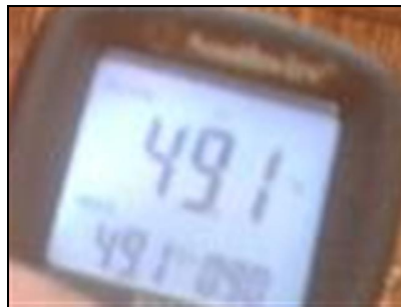
**11.0** Evaluations are usually restricted to the basic operation of electric central air conditioning and cooling systems. No heat gain, sizing, or design evaluations were performed. Thermostat calibration, accuracy and adequacy of conditioned air distribution were not determined. The evaporator coil (indoor coil) is not visible for inspection. Cool / cold weather operation / evaluation is not part of a standard inspection. No assessment was made related to the use of or potential hazards of any system refrigerant. Client should consider having cooling system serviced by a qualified HVAC contractor. System rated fair due to age and functions as intended.

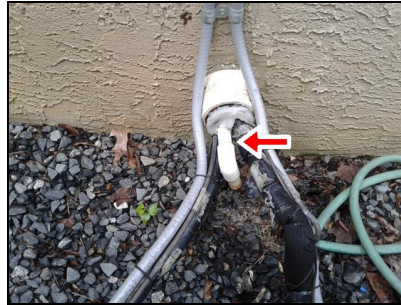
Condensation drain left side

**11.2** Observed that the condensation drain lines need to be extended outward away from the foundation. Condition is conducive to water laying against foundation and crawl space water penetrations. This can also cause softening of the soils around the foundation and lead to other potential damages. Evaluation / Correction by a qualified handyman contractor is recommended for this entire condition.

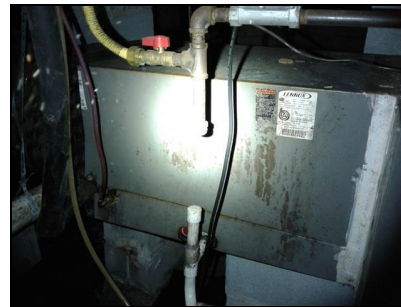
First floor indoor AC coil unit

**11.4** Per the standards of practice all NC / SC home inspectors are only required / allowed to remove readily accessible panels for inspection. In regards too the indoor coil units some of these panels cannot be removed due to design / obstructions / seal tape and or mastic compound. These indoor coil units work in tandem with the condenser unit outside to produce the air conditioning. Although temperature readings indicate that the unit was functioning properly at the time of inspection, it is recommended that a qualified HVAC contractor further evaluate due to no service information revealed / given to FSHI at the time of inspection.

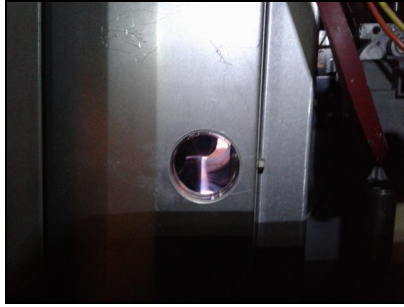
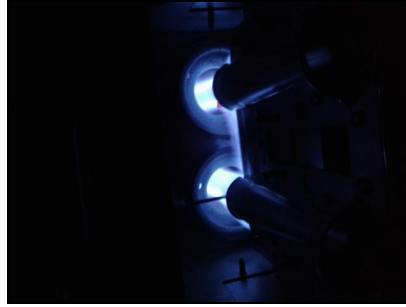
**12.1** Heat exchangers / burner compartments are not inspected except thru available grille. System has to be dismantled for this type of inspection and is technically exhaustive. Some systems do not have available access to visually see thru grille to view burner compartment. Client should consider having heating system serviced by a qualified HVAC contractor.

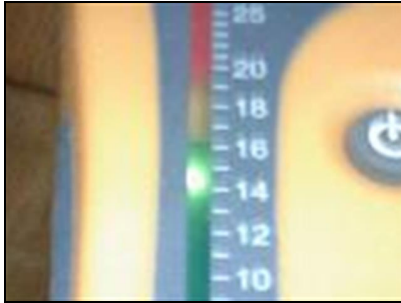
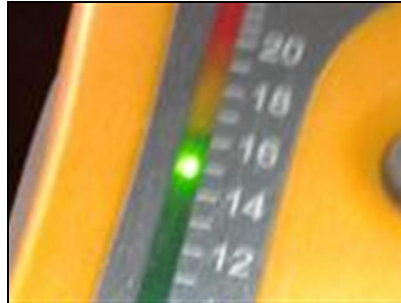
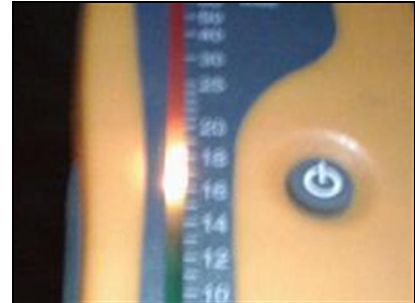
**14.6** Documented moisture readings from the substructure at the time of inspection.

14% moisture

15% moisture

18% moisture
